Physical Modeling of Deflector Arms in a River Table

PHYSICAL MODELING OF DEFLECTOR ARMS IN A RIVER TABLE

by
Djibrilla Rapant
Candidate for Bachelor of Science
Environmental Resources Engineering
With Honors

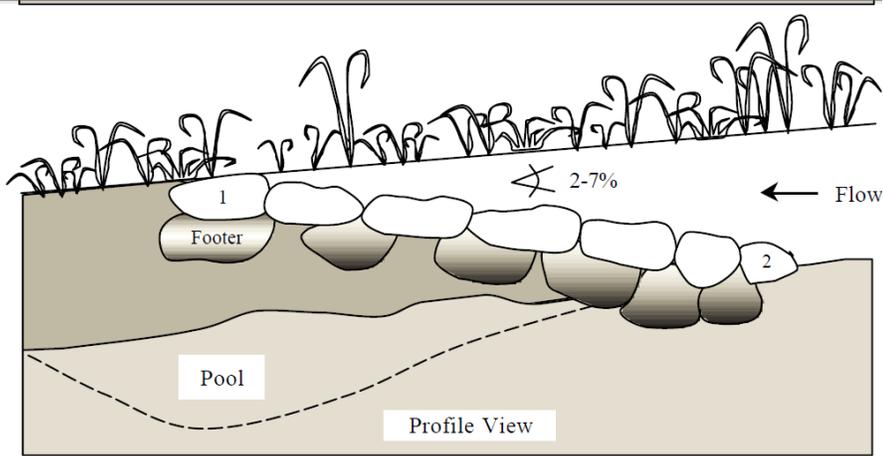
Figure 3: Profile View of Example Rock Vane

(Rosgen, 2001)

boulder width, roughness, and gaps. The deflector arm can be placed at a 20 to 30 degree angle from the bank, and the slope of the arm can be between 2 and 7 percent (Rollins, 2003). Although a 20 degree angle provides protection for the greatest length of stream bank (Rosgen, 2001) a 30 degree angle was used in experimentation due to ease of implementation. Profiles are shown in figures 3 and figure 4.

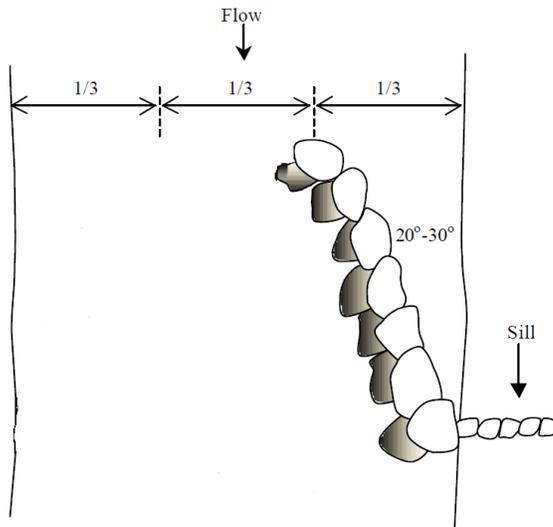
Figure 4: Plan View of Example Rock Vane

(Rosgen, 2001) Plan View

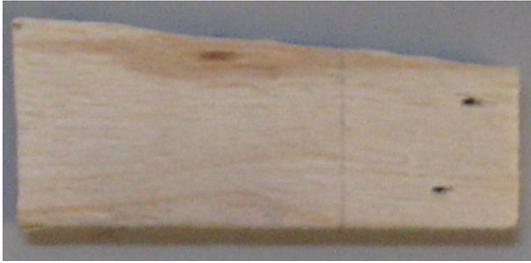
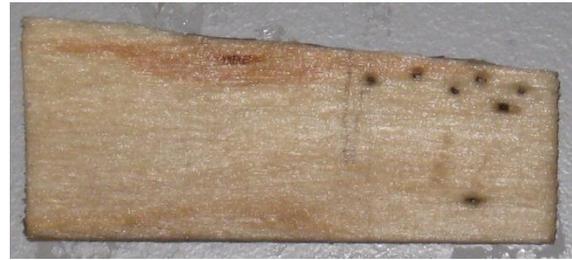
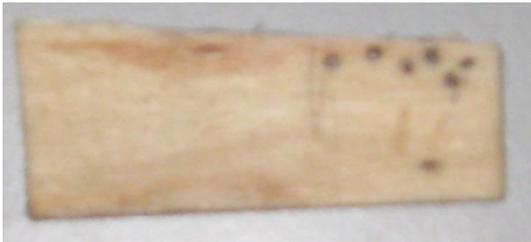
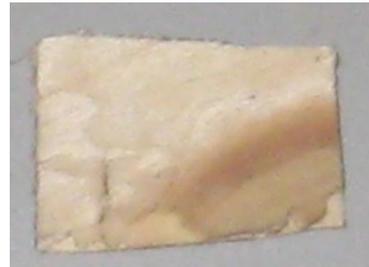
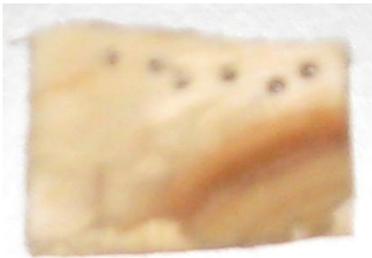
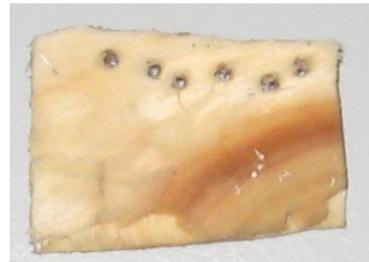
Figure 6: Deflector Arm Models

Structure 1

Structure 2

Structure 3

Structure 4

Structure 5

Structure 6

3. The deflector arm models are shown in figure 6. Structures 1 through 3 have longer key lengths than 4 through 6. Structures 1 and 4 have no holes in their design. Structures 2,3,5,6 have holes which vary in size. Figure 5 details the design specifications of the deflector arm models. Assumptions and problems encountered during this step of the experiment are discussed in the results section.

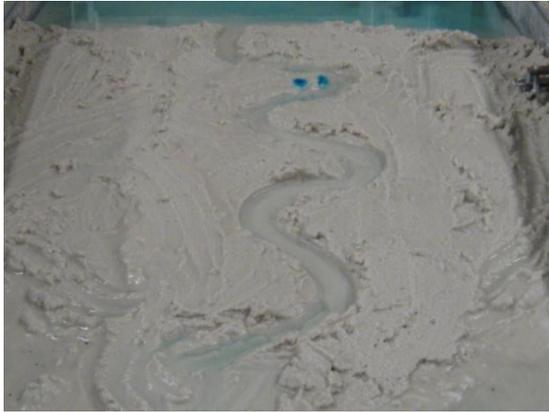
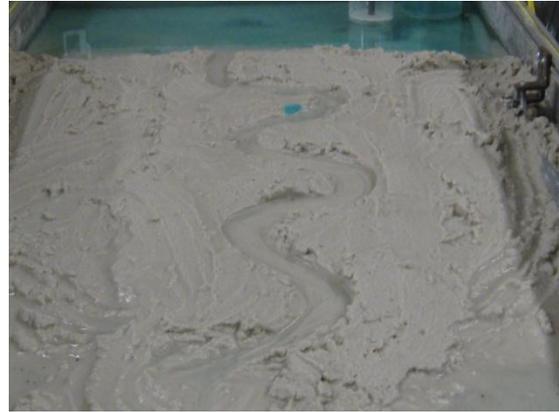
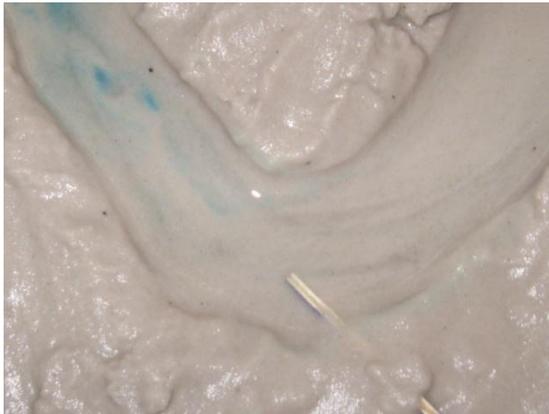
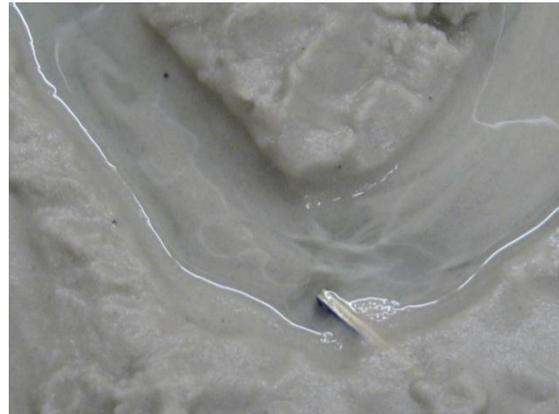
Figure 10: Test 2 Before and After
Before

After

structure 2 performed best of all structures due to low ranking in presence of erosion and hence minute change in stream geometry (see figure 10). By contrast, the photo analysis revealed structure 5 resulted in the greatest extent of downstream and bank erosion (see figure 11).

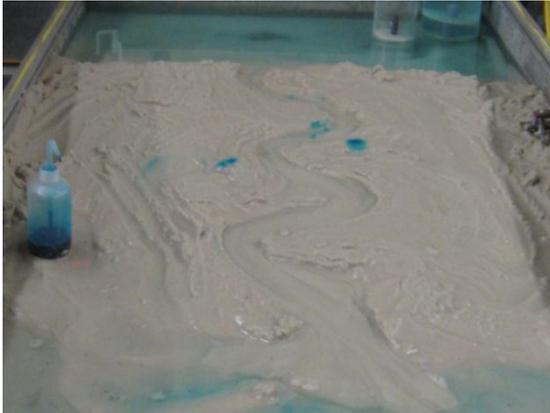
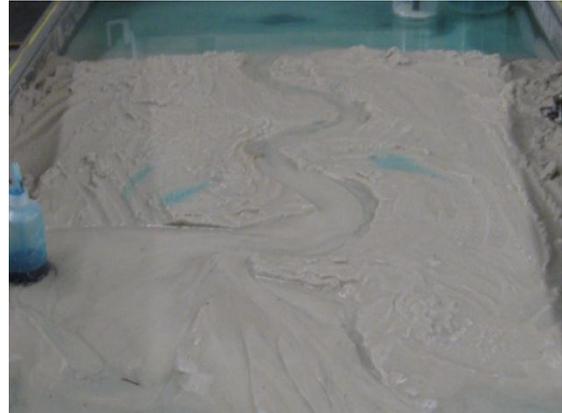
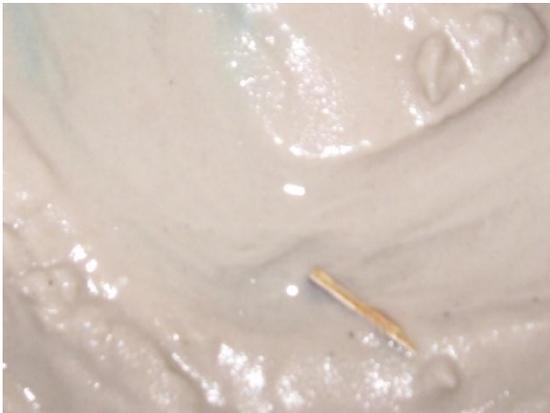
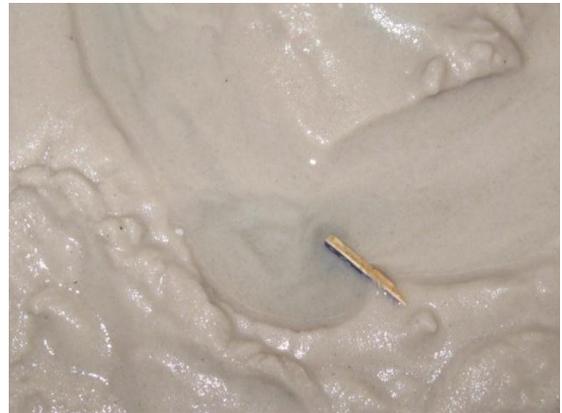
Figure 11: Test 5 Before and After

Before

After
